## Test Report

67-C1598-3462

HWA LIN STAINLESS STEEL INDUSTRY CO., LTD.

N4+NSR

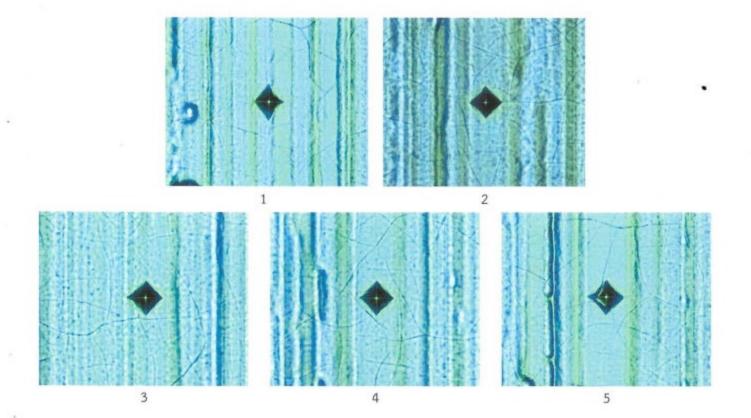
Micro Hardness Tester (Vickers), Shimadzu, HMV-G31-FA-D-HC60

HV0.1 (980.7 mN)

Test Result:
